PASSAIC RIVER BASIN  
STONY BROOK TRIBUTARY, MORRIS COUNTY  
NEW JERSEY

**BOONTON RESERVOIR DAM**

**NJ 00255**

**PHASE 1 INSPECTION REPORT  
NATIONAL DAM SAFETY PROGRAM**

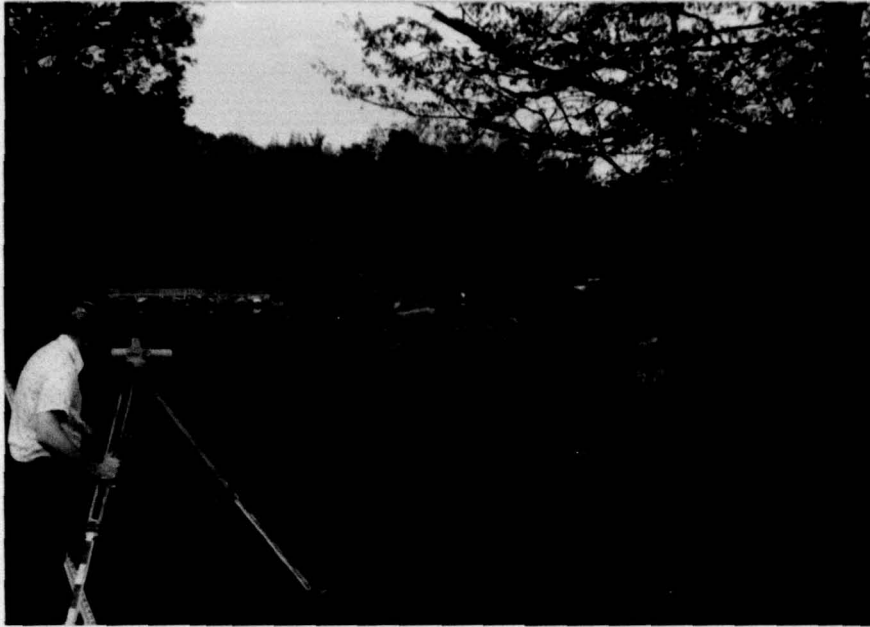
VIEW OF DAM CREST FROM LEFT SPILLWAY ABUTMENT  
TOWARDS ROAD

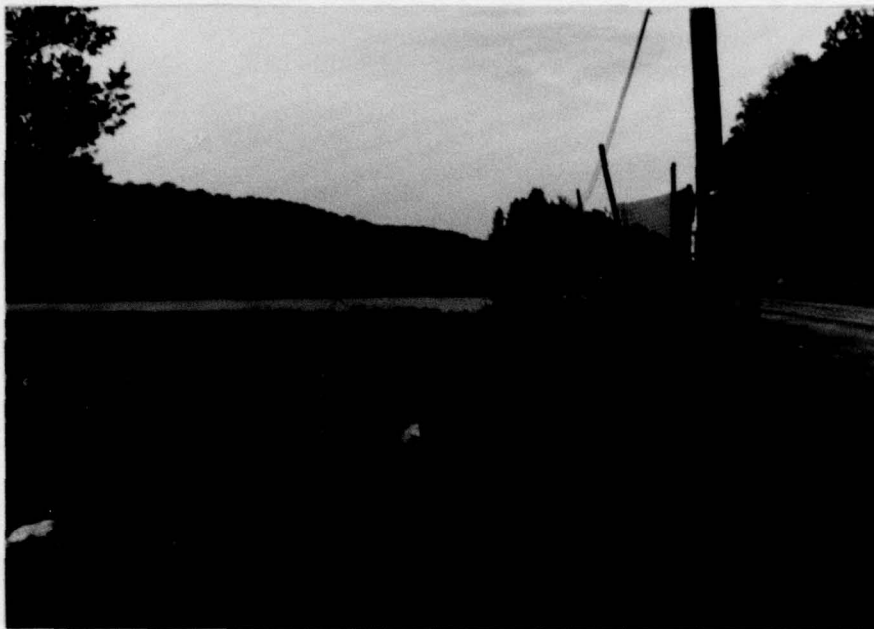
CONTACT AT LEFT ABUTMENT
